SOME COMMON PROBLEMS WITH LASER CUTTING MACHINES

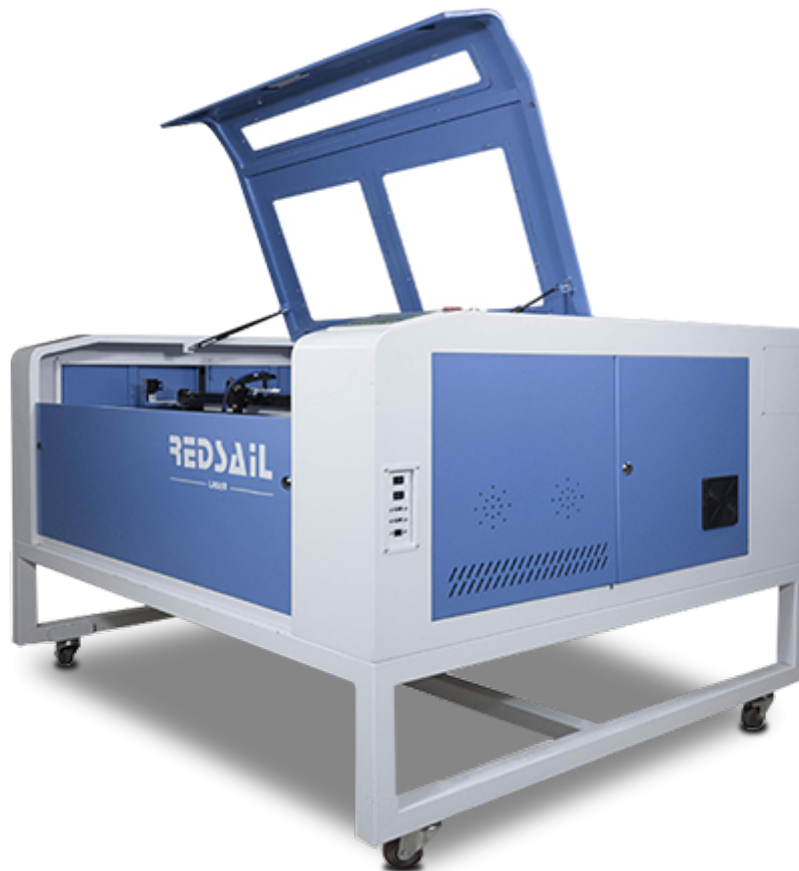
The laser cutting machine has been warning of insufficient compressed air supply.

laser cutting machine
